ACTION MEMORANDUM – RV1

SUBJECT: Request for Authorization and \$2 Million Exemption for the CERCLA Removal Action at the Beechnut Nutrition Corp. Site Canajoharie, Montgomery County, New York

ACTION MEMORANDUM FOR THE
BEECHNUT NUTRITION CORP. SITE
CANAJOHARIE, NY
SITE ID# A26B

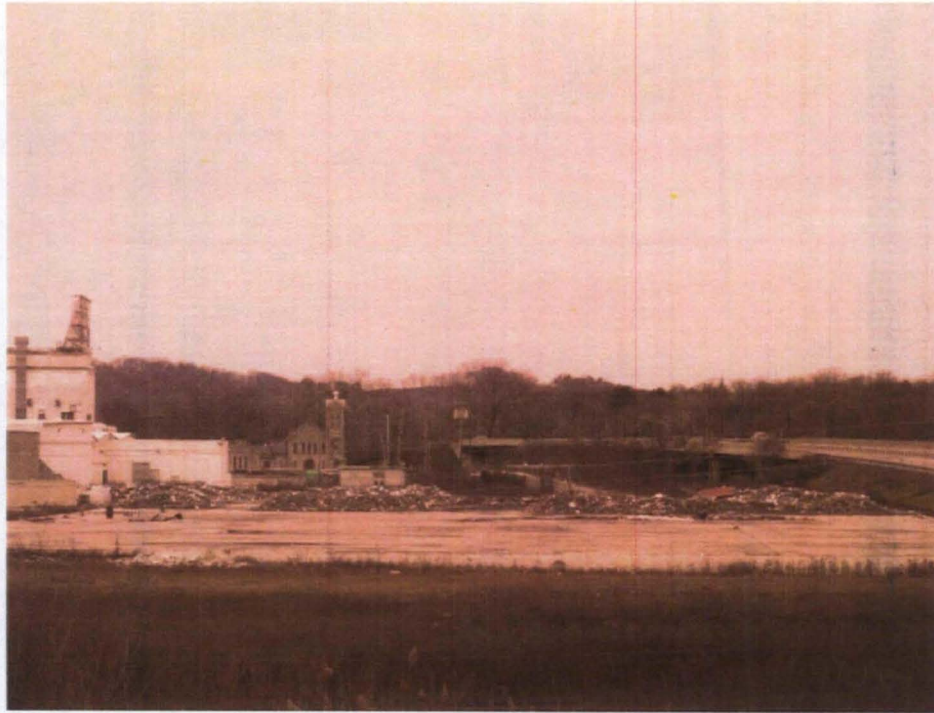
View from entrance to NYS Thruway. Masonry blocks piled on concrete foundation.

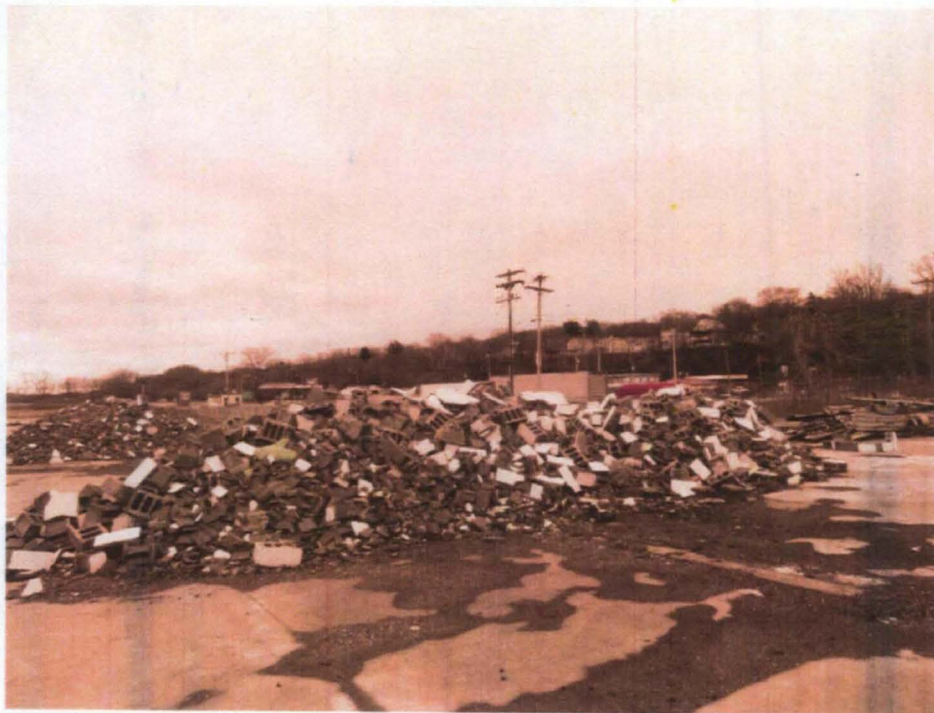
Piles of masonry block which used to be warehouse walls and foundations.

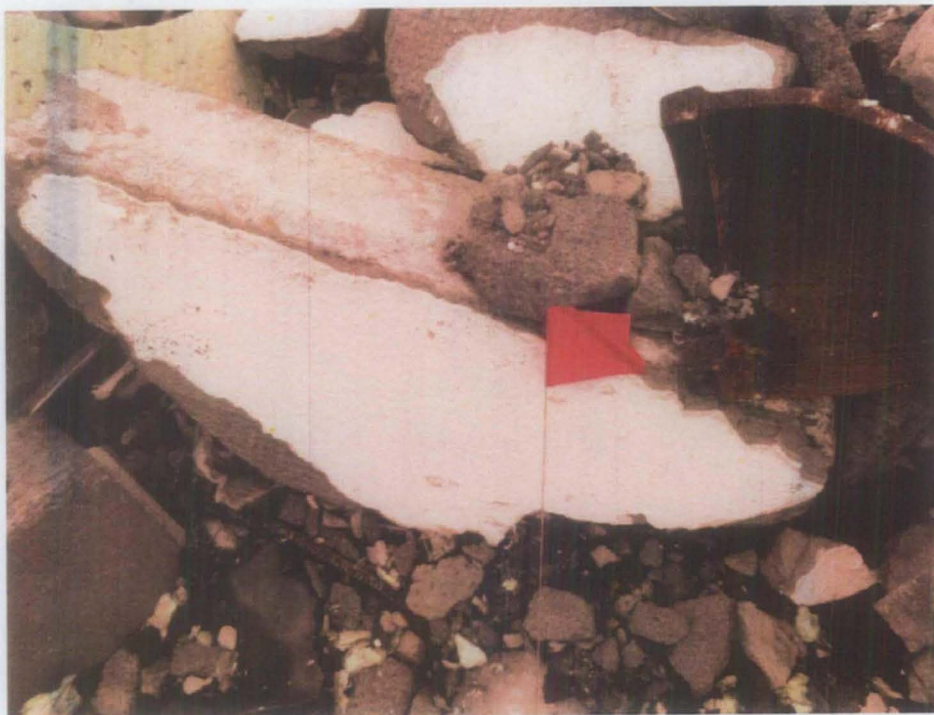
The laboratory separated each sample and analyzed the coating material independent of the mortar/cinderblock. All coating samples were found to contain asbestos in concentrations between 1.18% and 2.48% friable chrysotile. Asbestos was additionally found in the mortar or wall material of sample location BULK30. The asbestos contained in the walls and piles represent the most immediate threat to human health and the environment.

Profile view of coating on the masonry block.

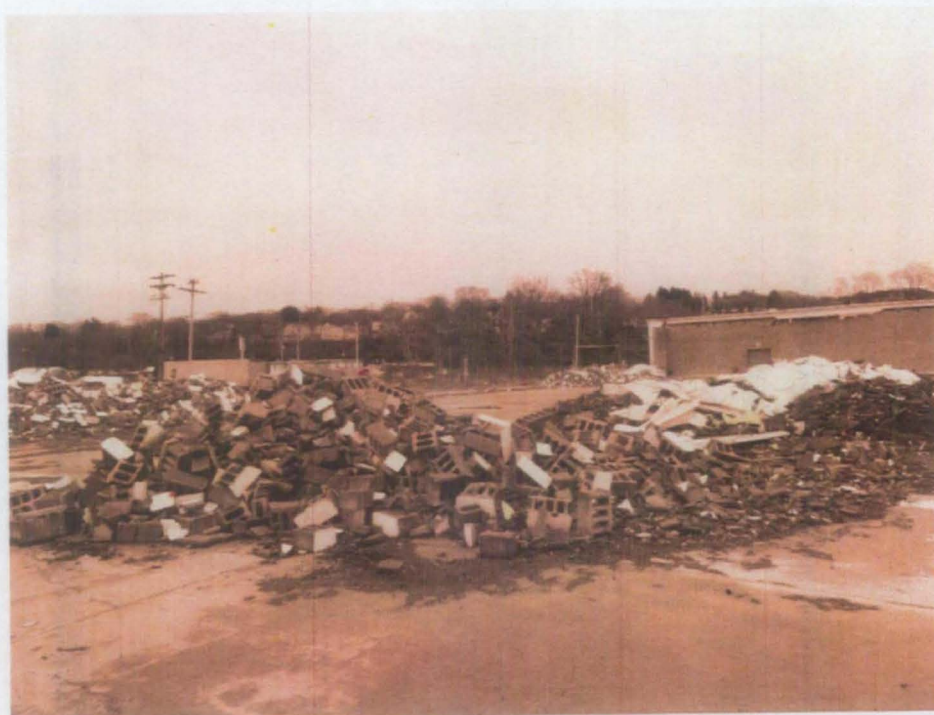
Approximately 11 piles, of various sizes, of masonry block are located in the Eastern portion of the Site.

- Establishing containment barriers to the extent practicable to limit the migration of asbestos from the Site property;
- Bulk removal of asbestos debris piles;

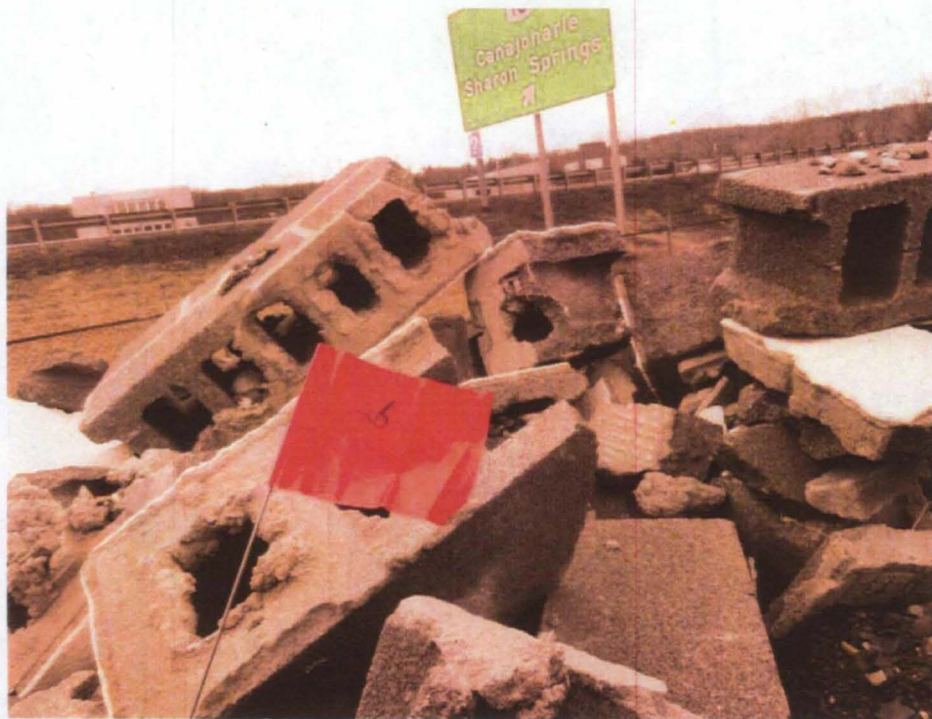
Sample results indicate the presence of ACM in the exterior eastern section of the Site, which is subject to weathering. Masonry blocks coated with ACM are exposed to weather events, as well as heat and cold during summer and winter. Exposure to the elements may cause the coating material to degrade, crack, flake, and separate from the masonry block. Weathering causes the matrix which binds the fibers together to be broken down, releasing the fibers to the environment. Once in the environment, the mineral fibers persist and do not readily break down further. Wind traveling across the Site may cause asbestos fibers to become entrained in the air, increasing the likelihood of being carried downwind. In addition, rain and snow events may cause ACM to be transported to sewer systems, the Canajoharie Creek, the Mohawk River, Downtown Canajoharie, or areas near the Site, including residential areas.

Piles are located near highway exit/entry ramps and exposed to weathering.

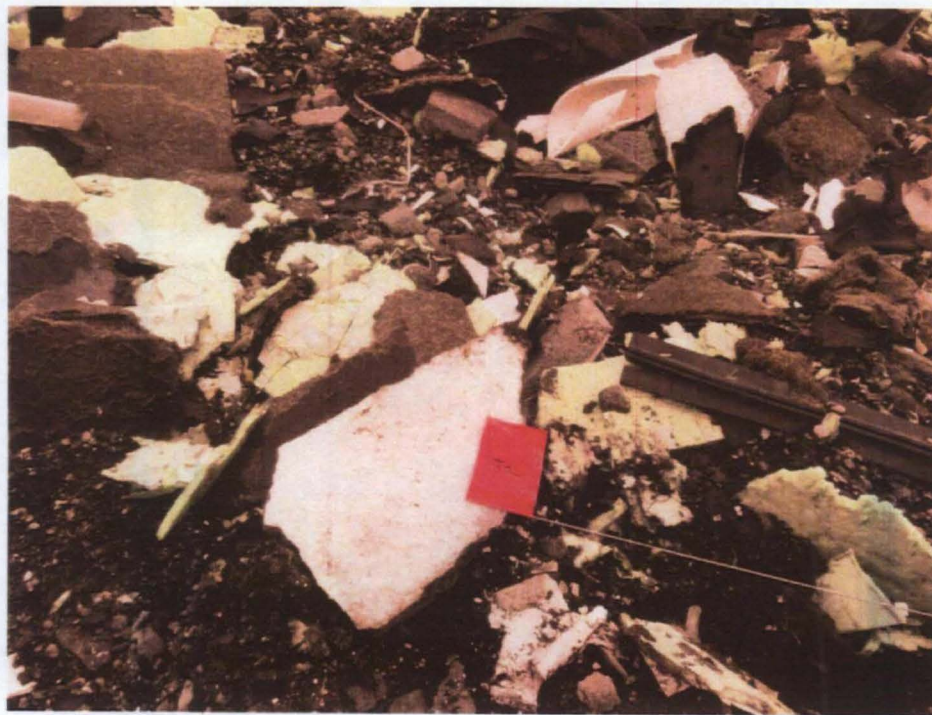
Some piles are comingled with other debris, such as roofing material.

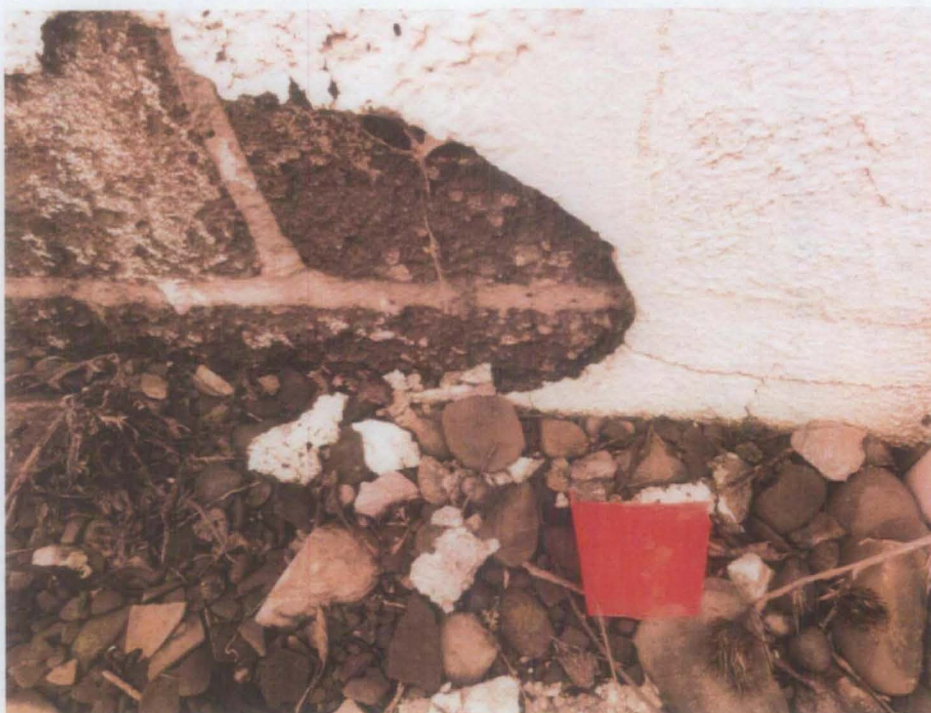
Coating on exterior walls, found to contain ACM, is coming apart.

- Spraying and containing of friable asbestos coating located along the exterior walls which are the subject of this removal action;
- Demolition and disposal of partial walls as necessary;

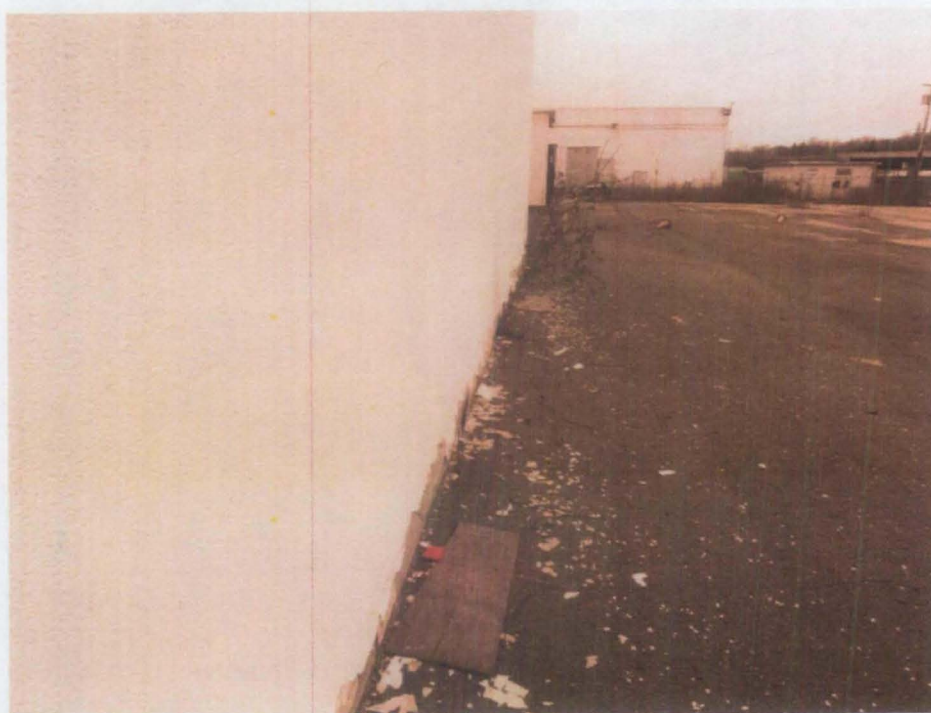
All along the bottom of the exterior walls, the coating is peeling, cracking and coming off.
